Access Audit – SH College, Thevara

17th October, 2011

Introduction

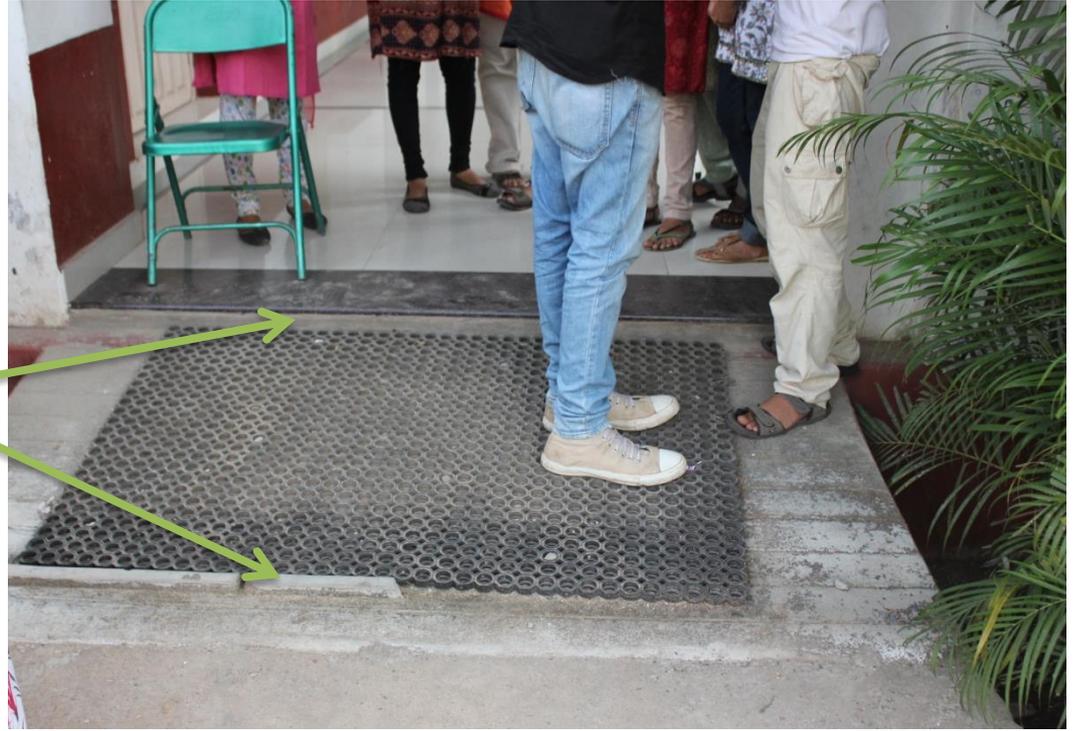
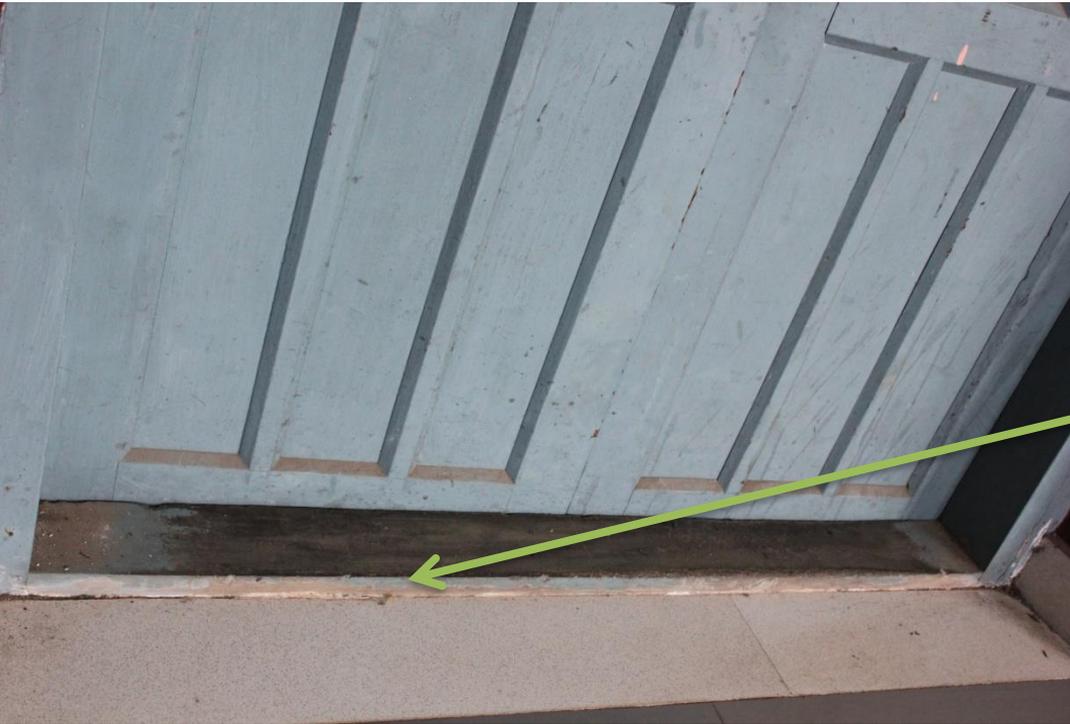
Ramp - Though the ramp is there in the main entrance, it is insufficient for its purpose. The level difference in the beginning and the end is to be merged to provide unhindered access to wheelchair users.

Though the ramp is there in the main entrance, it is insufficient to its purpose. The level difference in the beginning and the end is to be merged to provide unhindered access to wheelchair users.

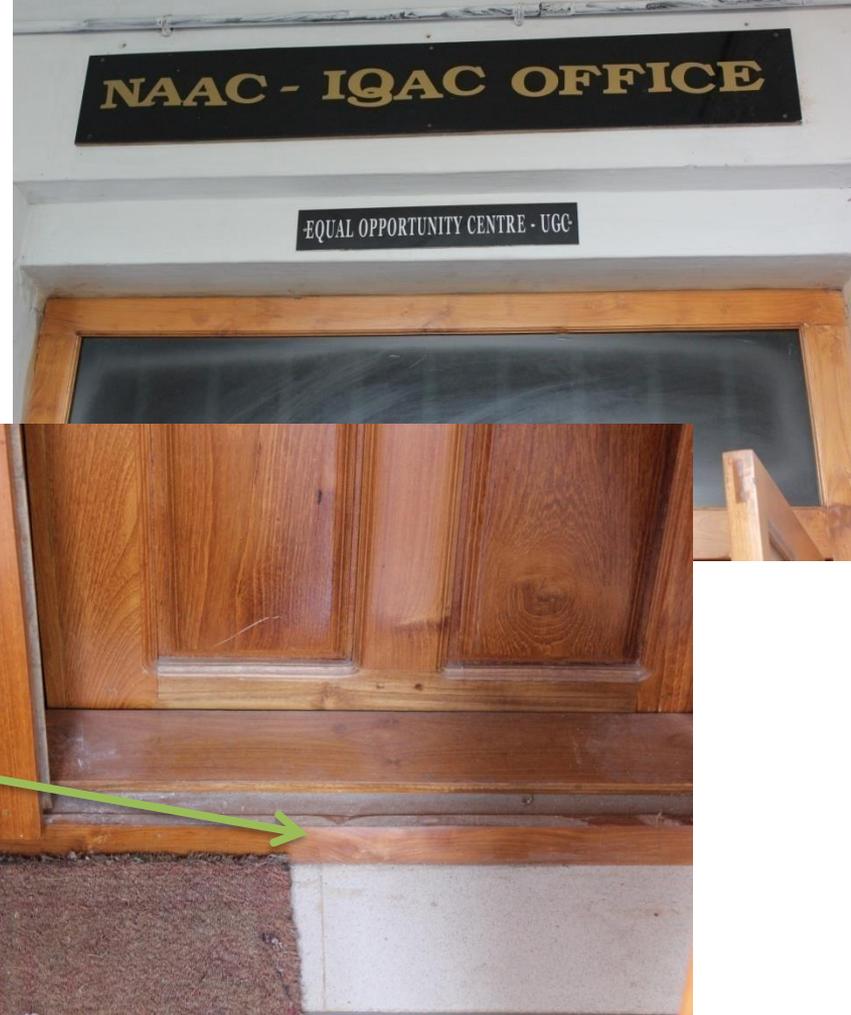
Thresholds - Threshold/height difference between corridor and room height is more than 10mm in all doors – it should be reduced or removed or be merged with the floor. Equal opportunity centre is inaccessible – presence of the threshold makes it inaccessible. Library is also inaccessible because of the presence of the threshold. A movable ramp can solve the problem.

Threshold/height difference between corridor and room height is more than 10mm in all doors – it should be reduced or the threshold is removed.

IQAC
office/Equal
Opportunity
Centre –
threshold height
is 41mm

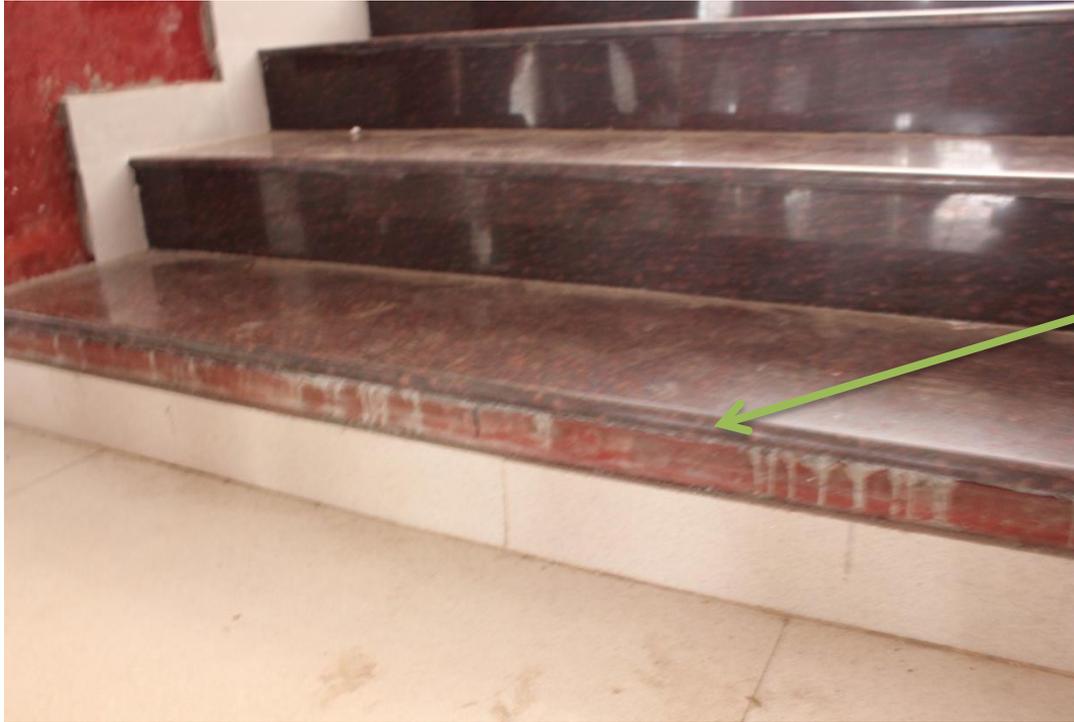
Stairs - Handrail is provided only on one side of the stairs. Handrails in contrast colours should be provided on both sides of the stairs at two levels - 700mm and 850mm. It should extend beyond the first and last step also. Round handrails with 30mm diameter in the lower one and 45mm for the top.

On the stairs – handrail is provided only on one side of the stairs.

Handrails in contrast colours should be provided on both sides of the stairs at two levels - 700mm and 850mm. it should extend beyond the first and last step also. Round handrails with 30mm diameter in the lower one and 45mm for the top. If possible steps' edges to have colour contrasted band 50mm, which benefits person with low vision to make out the depth and height of each step.

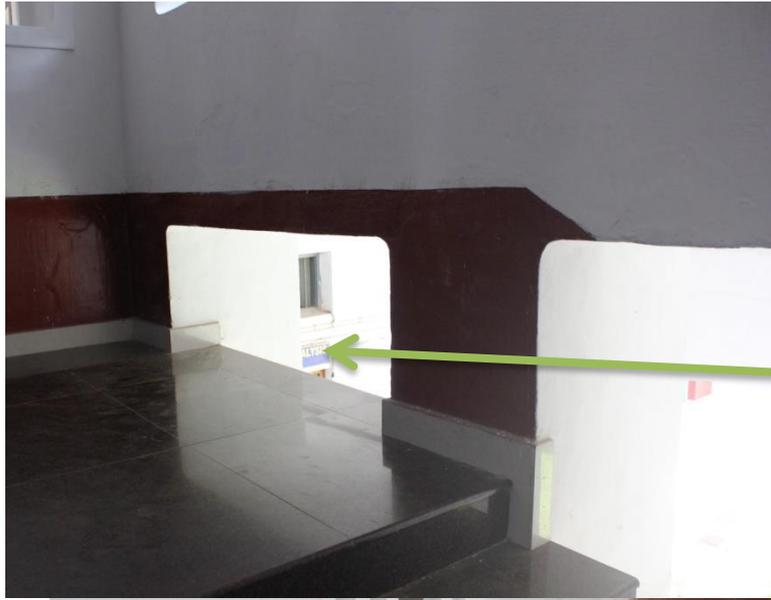
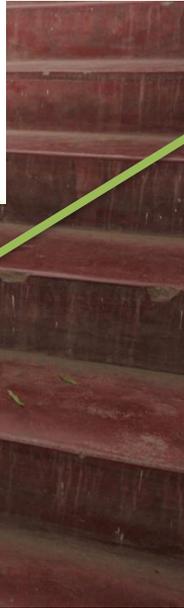
Nosing of
steps can be
avoided.

Gaps/holes in the side walls should be covered properly

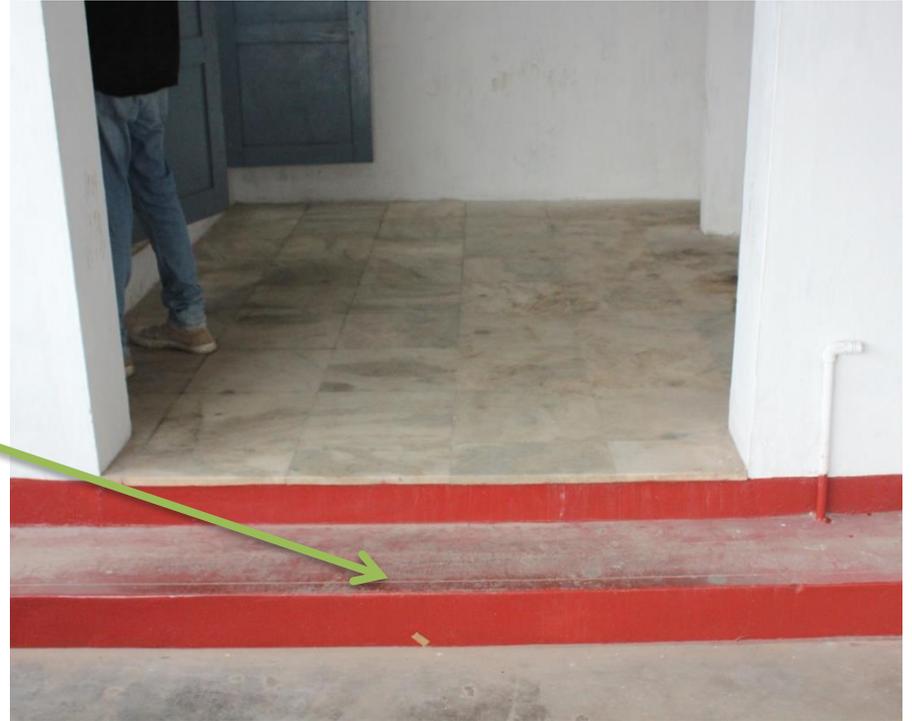
The width of the toilet is not sufficient for a wheel chair.

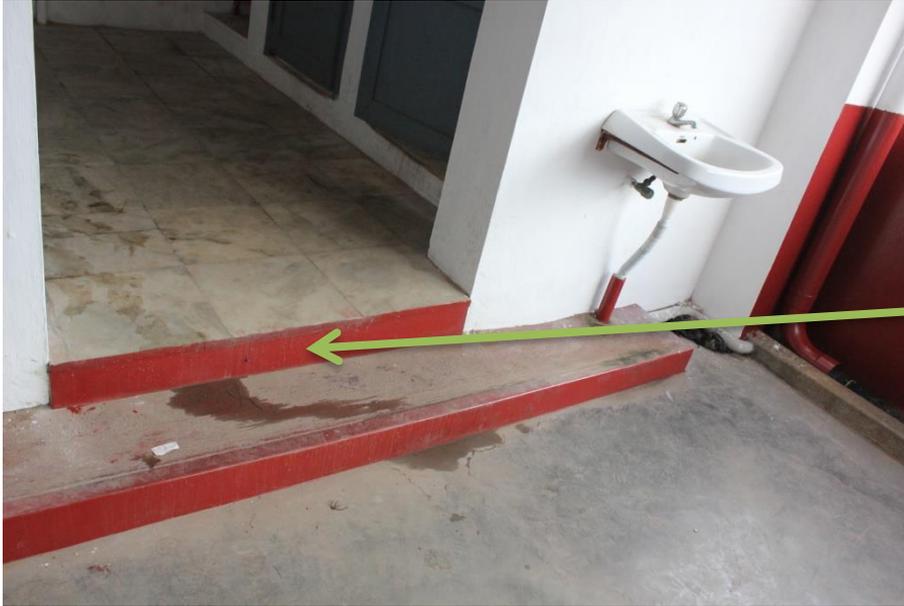
Steps to the girls' toilet on the 3rd floor make the toilet inaccessible to PwDs.

Grab bar should be fixed in the toilet
No flushes in the toilets. An additional accessible toilet can be provided.

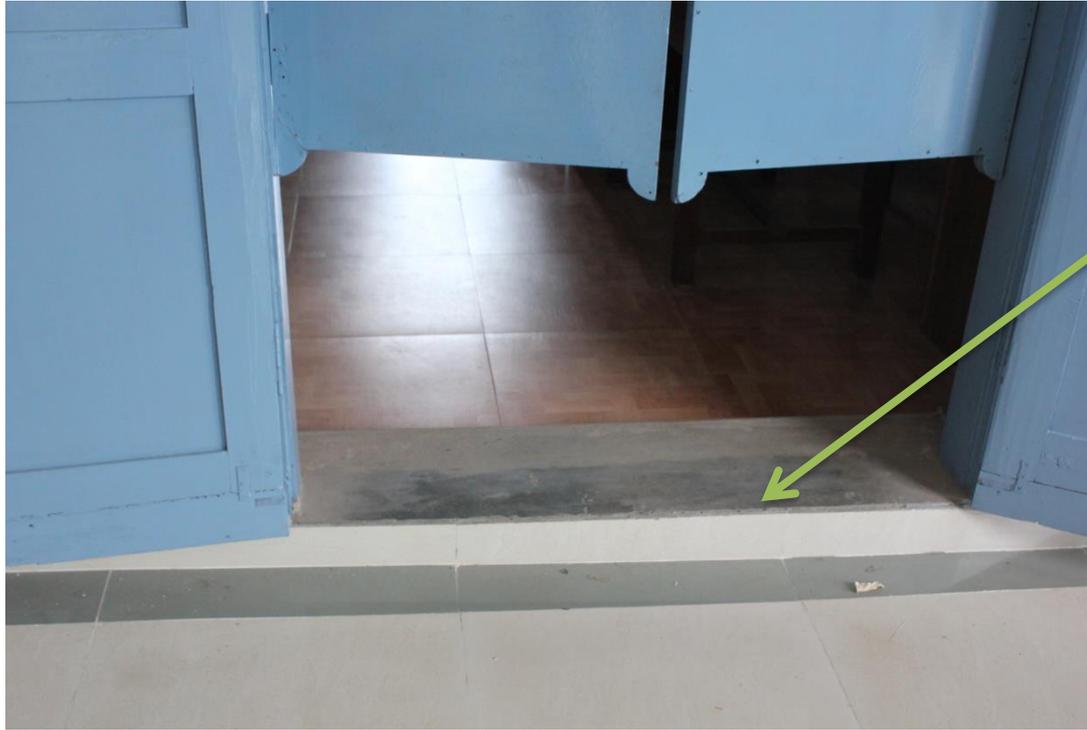
Threshold in the
sociology
department

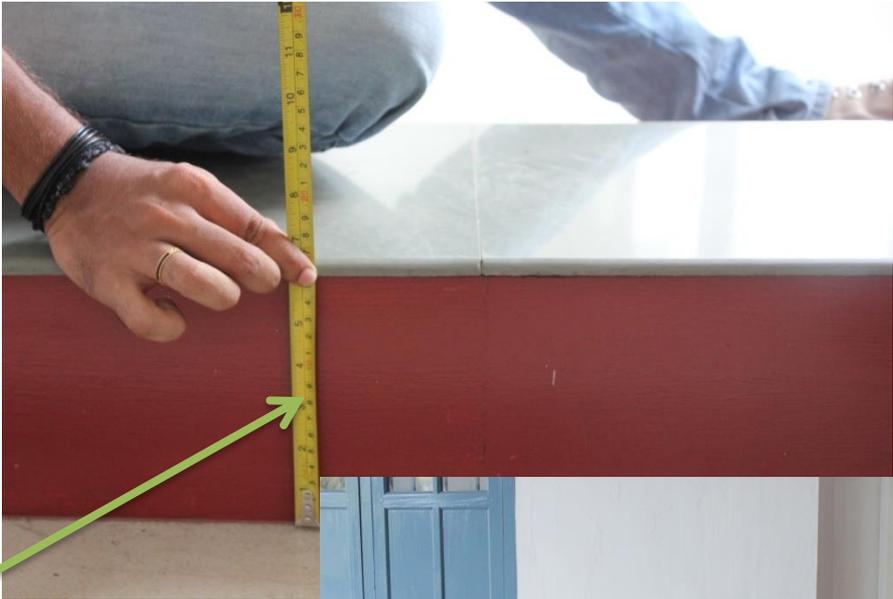
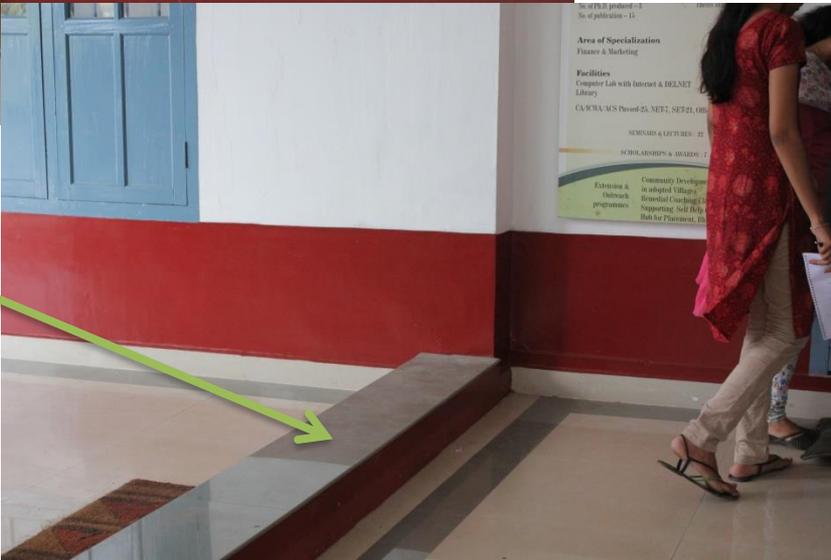
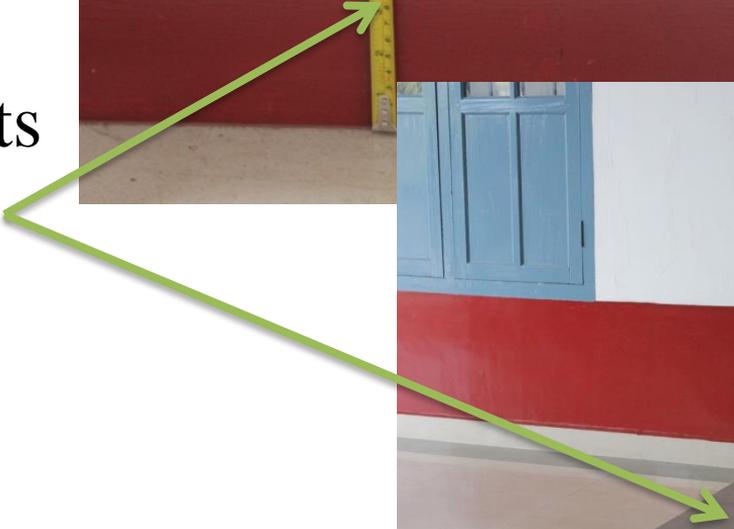
Beams in front of sociology and commerce department – if possible the beam should be removed or and easily identifiable/contrasted colour pattern should be given to the beams.

Beam in front of the sociology and commerce departments – dangerous

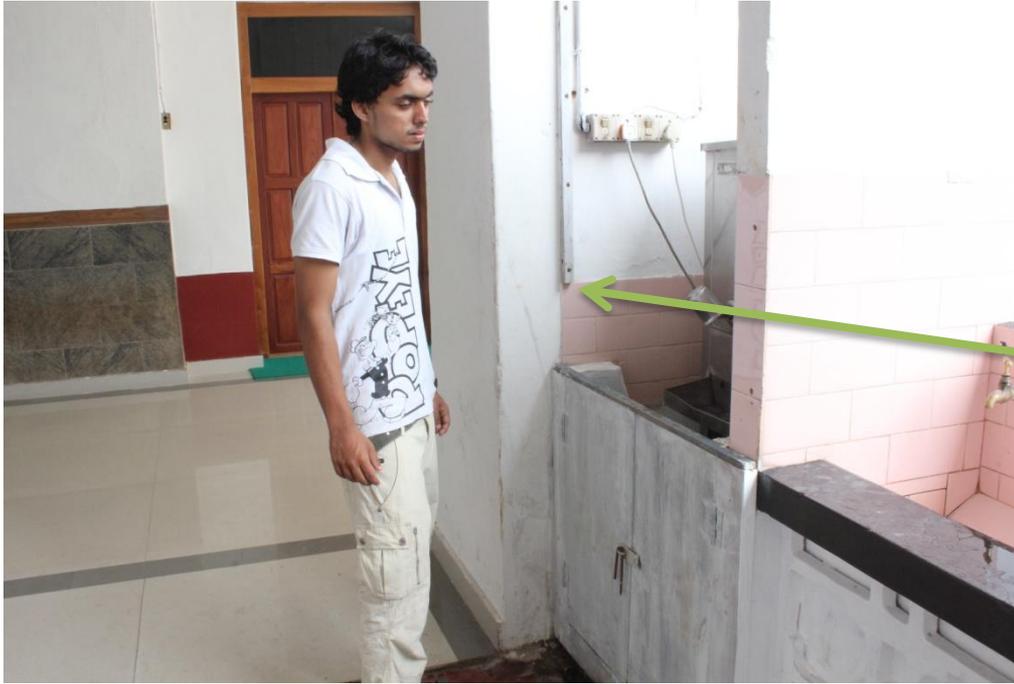
No glass holder
near the water
cooler.
Inaccessible for
PwDs

There is no access to a
person with physical
disability to the main
auditorium stage

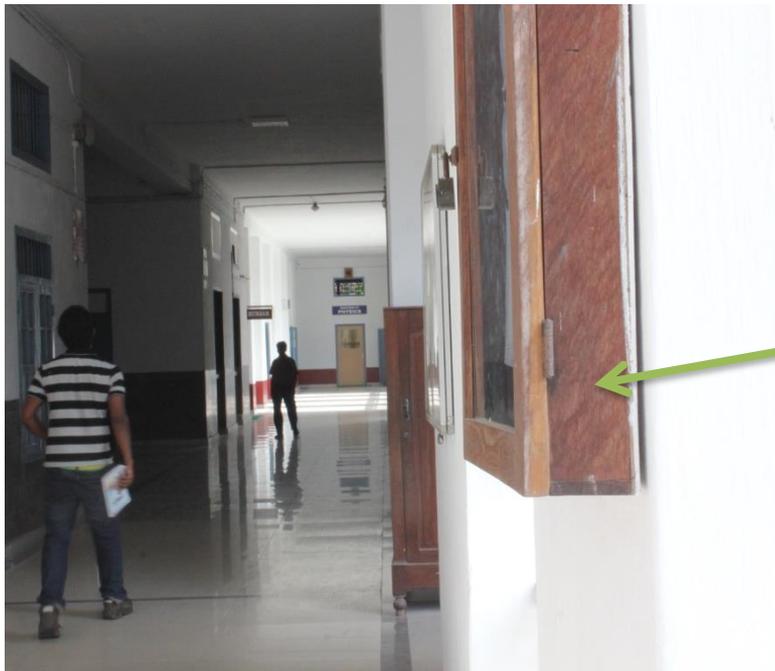
Showcases and notice boards are protruded in the corridors –

Showcases and notice boards in the corridors are dangerously protruded out from the wall

At least one of the working tables in the practical labs and computer lab should be lowered.

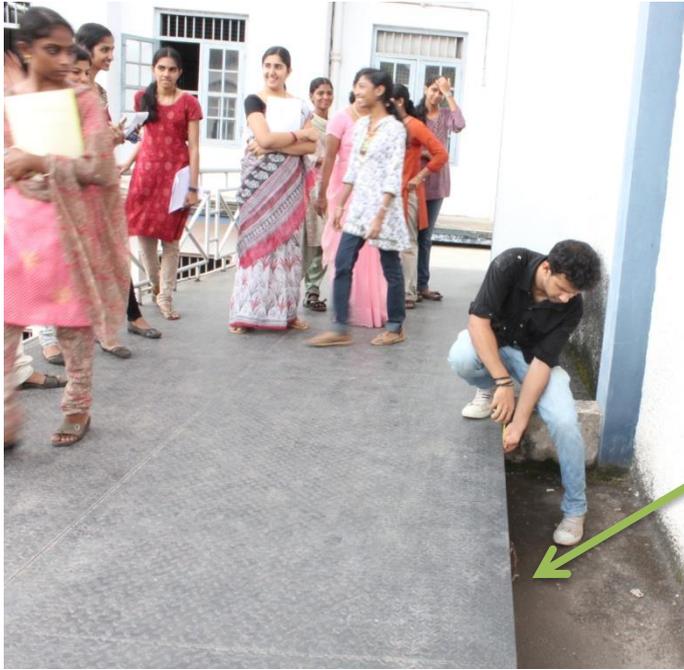
Gutters on corridor and the bridge between the main building and the north building should be covered. Gaps/holes in the side walls of the stairs should be covered properly.

Gutters on the bridge between main building and north building should have proper covering

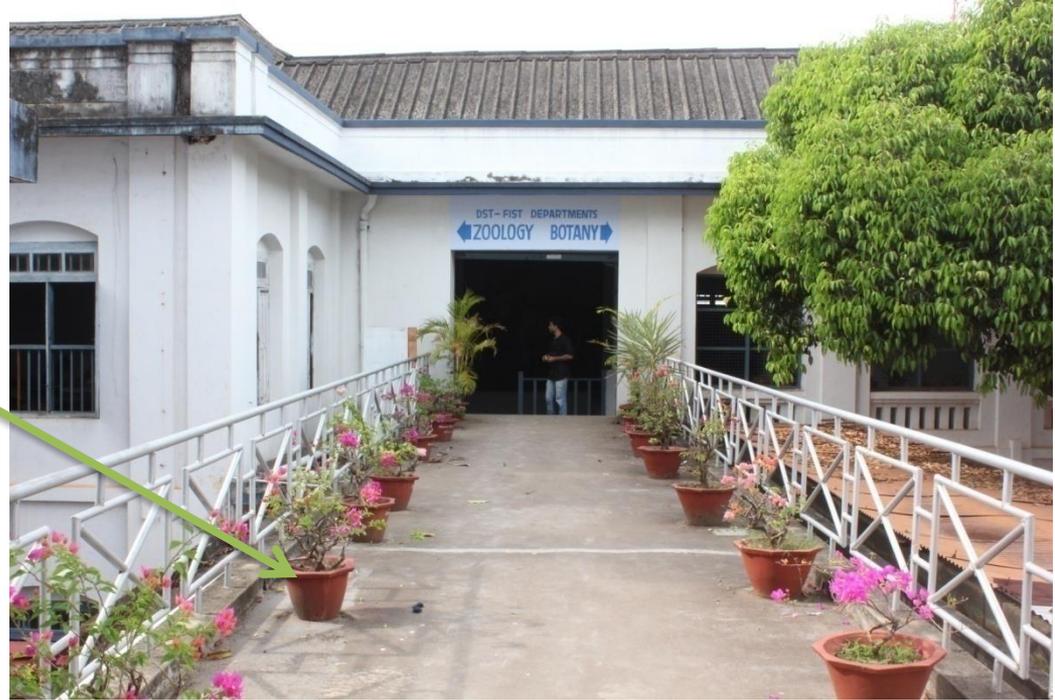
Pots on the bridge between main building and north building

Pots on the
bridge

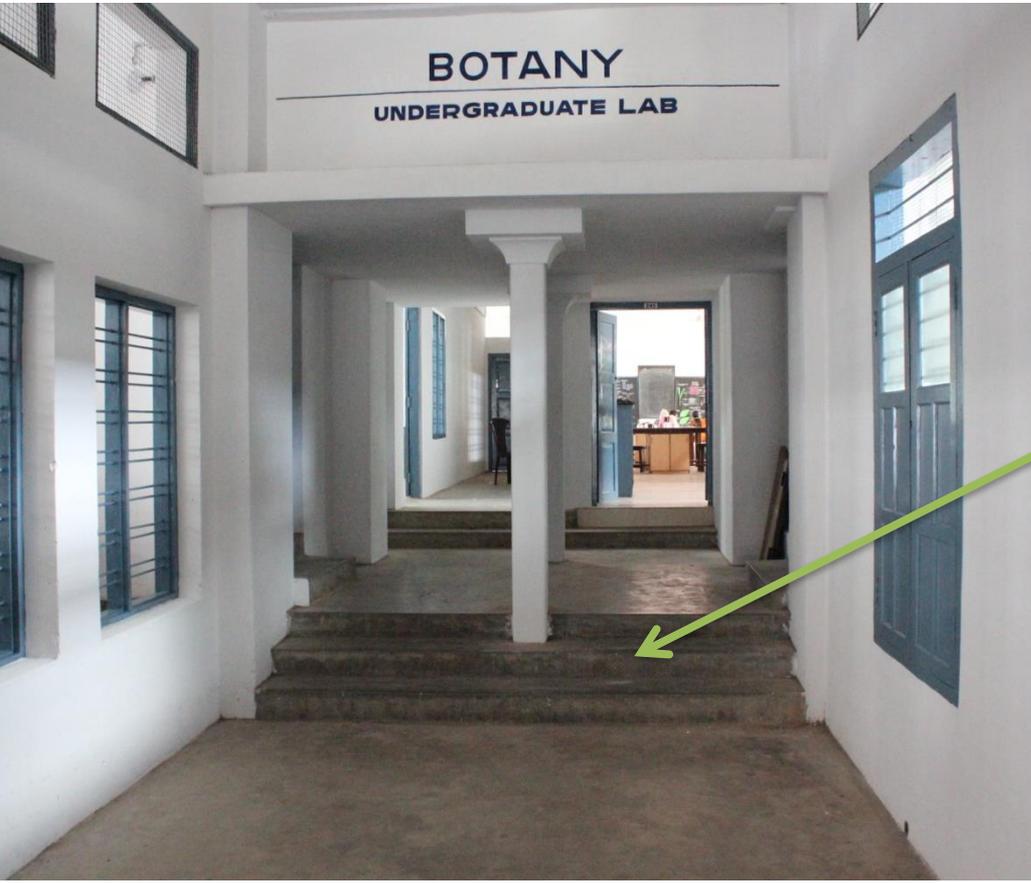
Steps to the Botany practical lab – Steps to the botany practical lab make the lab not accessible.

Steps on the way to botany practical lab make the lab unreachable.

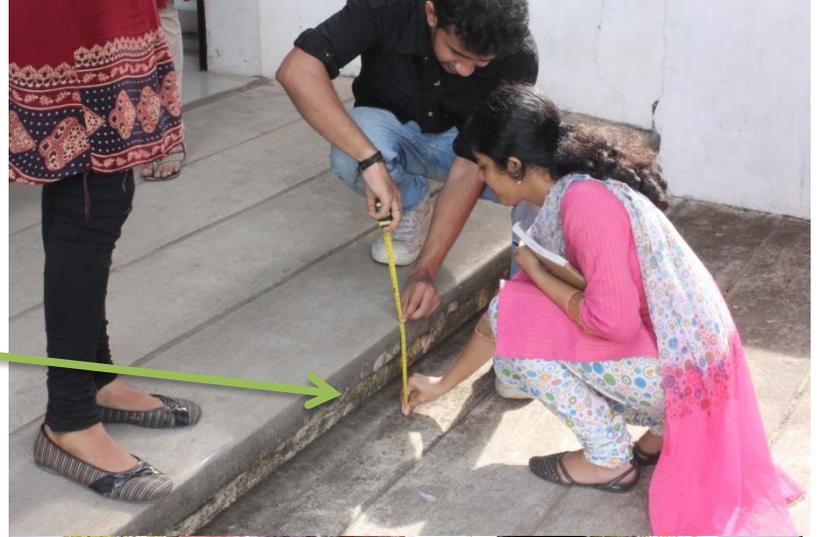
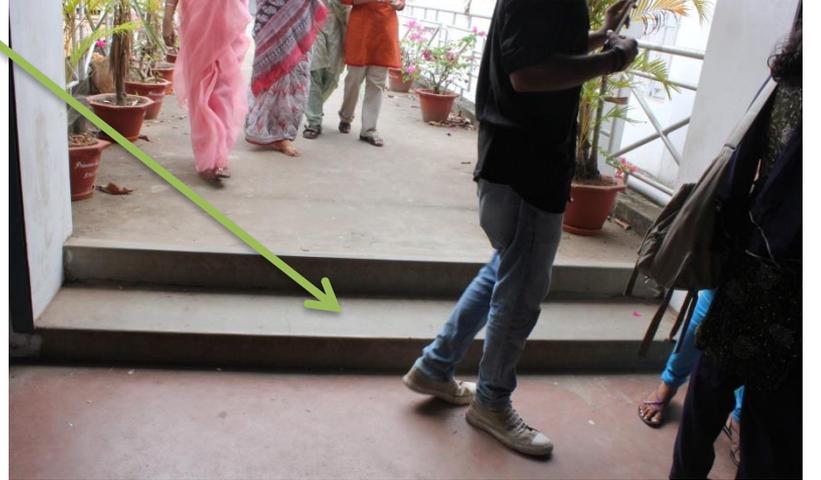
Bridge between main building and north building is inaccessible because of the steps in both sides of the bridge. Though it would be reduced

Steps on the two ends of the bridge between the main building and north building

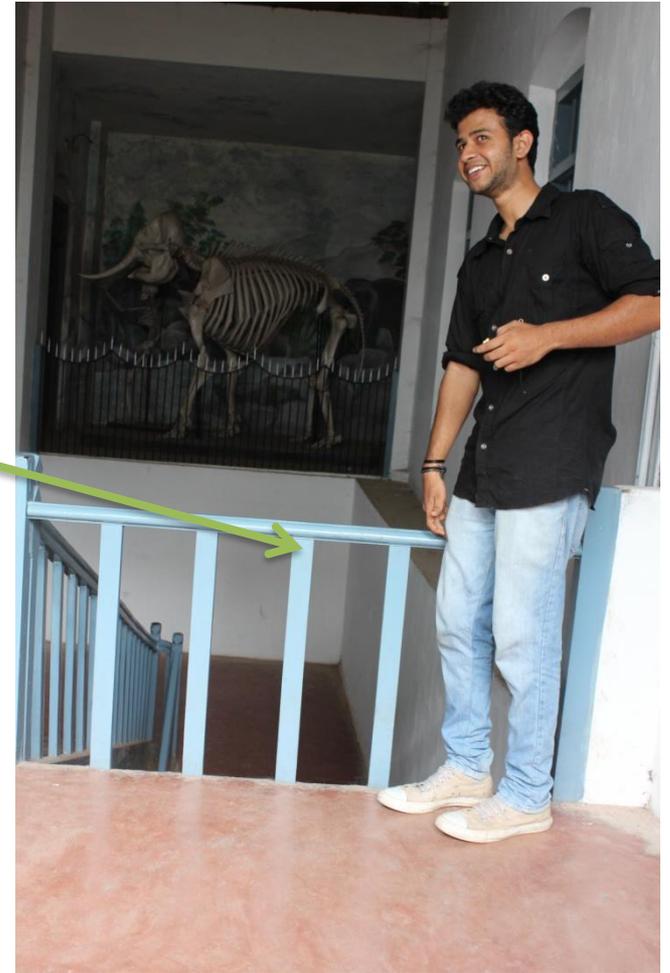
Height of the railing near the steps of botany department should be increased.
